## "Engine NVRAM Failure" Error 83 displayed on the Control Panel

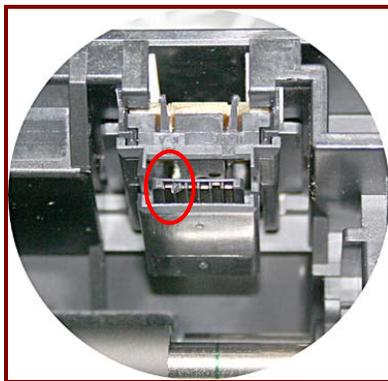
Figure 1.

This error condition indicates the Engine NVRAM is corrupted *or* is receiving incomplete or corrupted data from one or more of the CRUM's within the printer's consumables. Closing "Door C" with the Imaging Unit not fully seated can cause a misalignment of the CRUM connectors within the Imaging Unit and the Engine (PL7.1.4) resulting in damage to the Imaging Unit's CRUM connector. This damage consists of deformed plastic (Figure 1) within the connector that prevents the "reading" of the CRUM data by the Engine.

1. Remove the Imaging Unit and inspect the printer "cavity" for obstructions that may prevent the Imaging Unit from fully seating in the printer.
2. Inspect the Imaging Unit connector for any damage as shown in the figures above. Using tweezers, gently remove any deformed plastic from the connector housing. Install the Imaging Unit and gently push down on the top of the consumable to ensure it is fully seated in the printer. Close all doors and power cycle the printer to confirm the error condition has cleared.
